4 PLUMBING

5 FIRE PROTECTION

6 ELECTRICAL

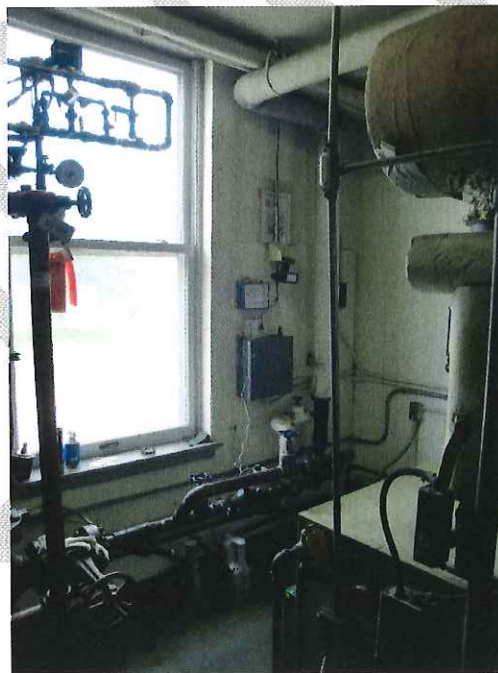
Photo #8

Our Island Home is provided with cold water from a 6" water main off the town system. The water enters the main mechanical room before it splits, with one (1) 6" branch serving the fire protection system and the other 3" branch serving the building cold water needs (see photo). The cold water piping is constructed of copper with soldered fittings, is original to the building and appears to be in good condition. Building water usage is metered by a Sensus water meter with a by-pass line for servicing. SMRT did not observe any back-flow prevention on the domestic water system to inhibit cross contamination.

- **Reduced Pressure Backflow Preventer:** Depending on the short and long term plans of the facility, current Massachusetts plumbing code requires reduced pressure backflow preventers. SMRT recommends that OIH consider adding one to the domestic water main.
- **Repair and replace existing Sink:** The single patient room bathroom sink should be replaced in order to make the bathroom usable. A plumber should be retained to inspect the existing water connections, drain and vent.

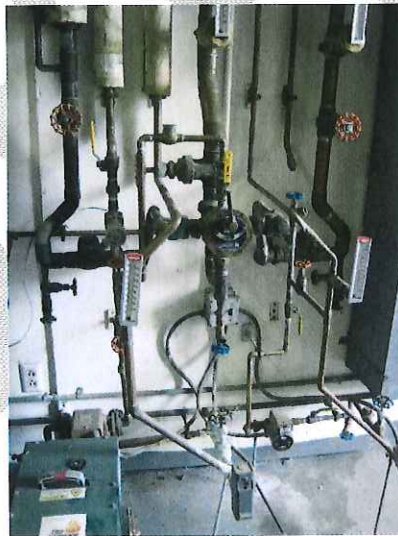
Photo #9

The mixing valve is a Leonard Type T valve and appears to be over 20 years old, perhaps original to the building. The valve is set to produce 120°F water. How water is circulated through the building by two bronze, Taco inline pumps (see photo below). The Taco pumps appear to be original to the building. The Leonard valve appears to be in good working condition with no issues to date. The two Taco inline pumps have outlived their useful life expectancy and although operational, should not be considered reliable.

- **Domestic Water Recirculation Pumps:** OIH should consider replacing the existing recirculation pumps. The pumps are original to the building and have outlived their useful life expectancy. Formal calculations to determine the flow rate required should be performed to ensure hot water reaches the desired point in a timely manner.

- **Mixing Valve:** OIH did not report any issues with the existing mixing valve, however as the valve ages it will begin to lose its authority and water temperature setpoints will be harder to maintain. SMRT recommends replacing the valve in kind. The domestic water heaters. Recirculation pumps and mixing valve should be done concurrently as one project for cost savings and warranty purposes.

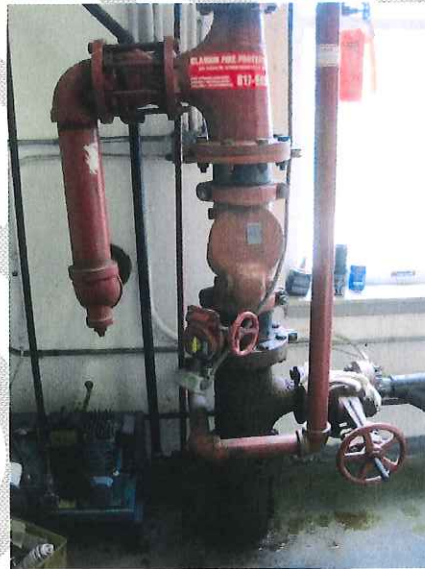
Photo #10

Our Island Home is protected by a dry pipe system, serving the occupied spaces and is routed in the attic space. The fire protection system is connected to the main 6" water service before branching through a 6" check valve. After the check valve, it reduces to a 4" pipe that tees to the dry valve and a 4" pipe to the Siamese fire department connection. The 4" Fiomatic dry valve is installed directly after the check valve and fire department connection. The dry pipe assembly is furnished with isolation valves, tamper switches, low air pressure alarms, main drain, air side and water side pressure gauges and water motor alarm (see photo). As noted above, the system appears to be on a regularly scheduled testing and maintenance program. Current NFPA 13 code requires a dual check valve assembly, where this system has a single check valve.

- Dual Check Valve Assembly: Depending on OIH's short and long term plans, SMRT recommends updating the existing fire protection assembly to include a dual check valve per code.

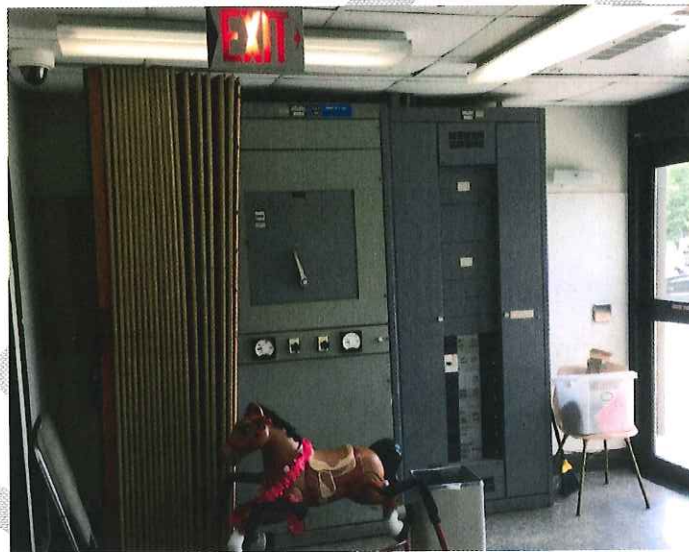
Photo 11: 800A Main Switchboard in egress corridor adjacent exit door.

Most of the feeder breakers are dedicated to branch panels located in small closets throughout the facility. Two breakers serve automatic transfer switches discussed under Emergency Power below. One breaker is labeled "Dryer". The switchboard did not appear to be maintained on a regular basis. The enclosure has surface rust and layers of dirt and dust on exposed horizontal surfaces. There was no arc flash labeling in place. Breakers were labeled with black marker. The switchboard's overall condition is poor. Based on a square foot analysis, the service is estimated to be loaded to less than 50%. Considering the age and condition, proper operation of the breakers under fault conditions is questionable. The service entrance switchboard should be replaced.

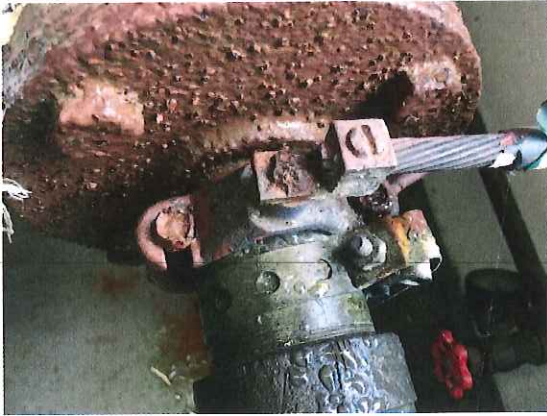
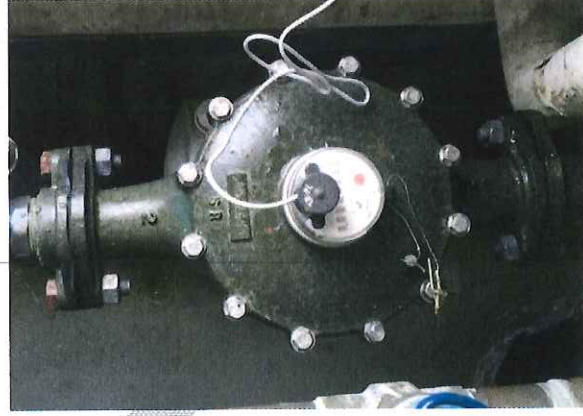
The service switchboard is grounded to the main water service in the boiler room. The grounding connection components are rusted and in poor condition. The ground bond to the main water service should be replaced.

Photo 12 & 13: Badly rusted ground bond water main; Missing jumper across water meter.

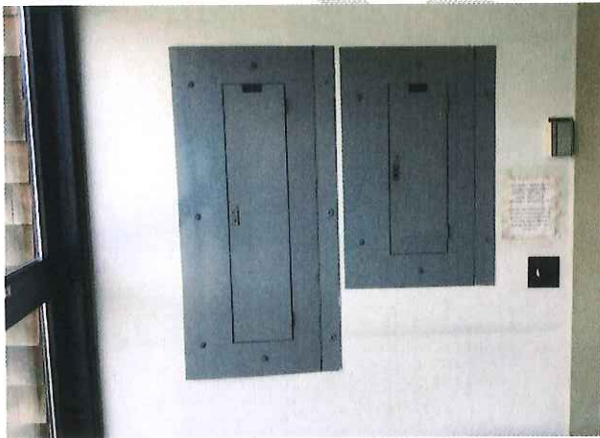
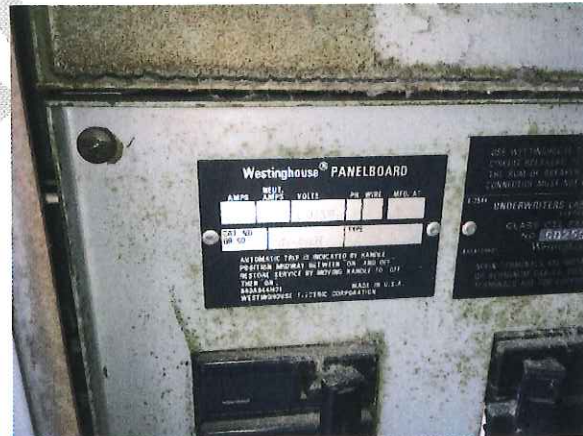
The existing branch panels throughout the facility were also manufactured by Westinghouse and are from the original 1980 construction. Some panels are located in dedicated electrical closets in the three patient wings. The door swing in these closets violates the code required working clearance requirements for this equipment. There are two panels in the staff core area, one in the kitchen, two in the corridor across from the service entrance switchboard at the South Wing exit door and one in the penthouse area. The panels are in fair to poor condition with surface rust and layers of dirt and dust. Considering the age and condition, proper operation of the breakers under fault conditions is questionable. These panels should be replaced.

Photo 14 & 15: Panel CPS & LPS; Interior surface rust, gaps in cover, heavy dust/dirt accumulation.

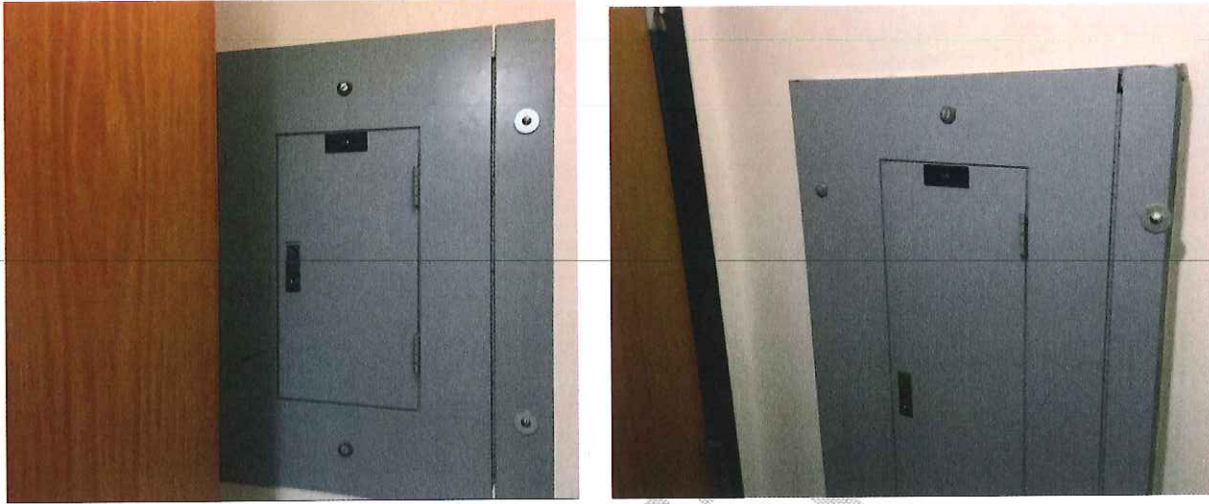
Photo 16 & 17: Panels CPW and LPE; Located behind door swing, working clearance code.

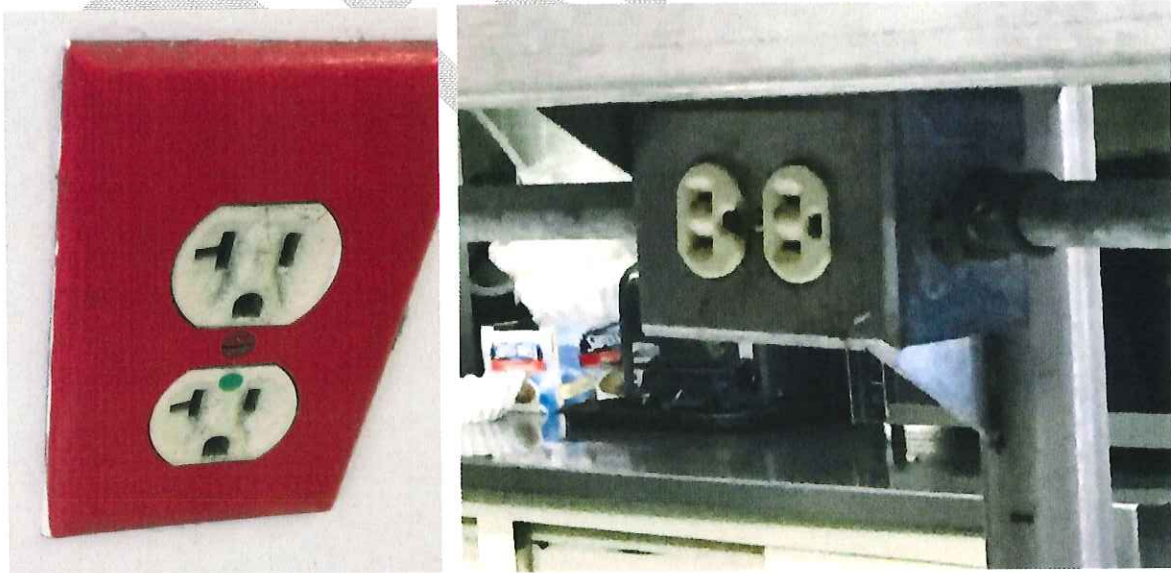
There is a mix of old and new receptacles across the facility. Many receptacles had green dots on their faces indicating they are hospital grade. Many were noticeably worn and in need of replacement. Ground fault circuit interrupting (GFCI) receptacles were observed in some locations but GFCI protection could not be confirmed for all locations where required by code. No GFCI receptacles were observed in the kitchen. Patient rooms were reported to have both normal and emergency power at each bed. As evidence of this, some receptacles were labeled in red marker with an "E" indicating emergency power. Those same receptacles include dedicated green grounding jacks, which are not required by today's codes. Some of the grounding jacks were damaged. Some receptacles in the corridors had red cover plates indicative of emergency power. The facility should have a single standard for receptacles (such as red devices and cover plates) to indicate which are on emergency power and which are on normal power.

Photo 18 & 19: Typical Worn corridor receptacle; Damaged, non GFCI kitchen receptacle.

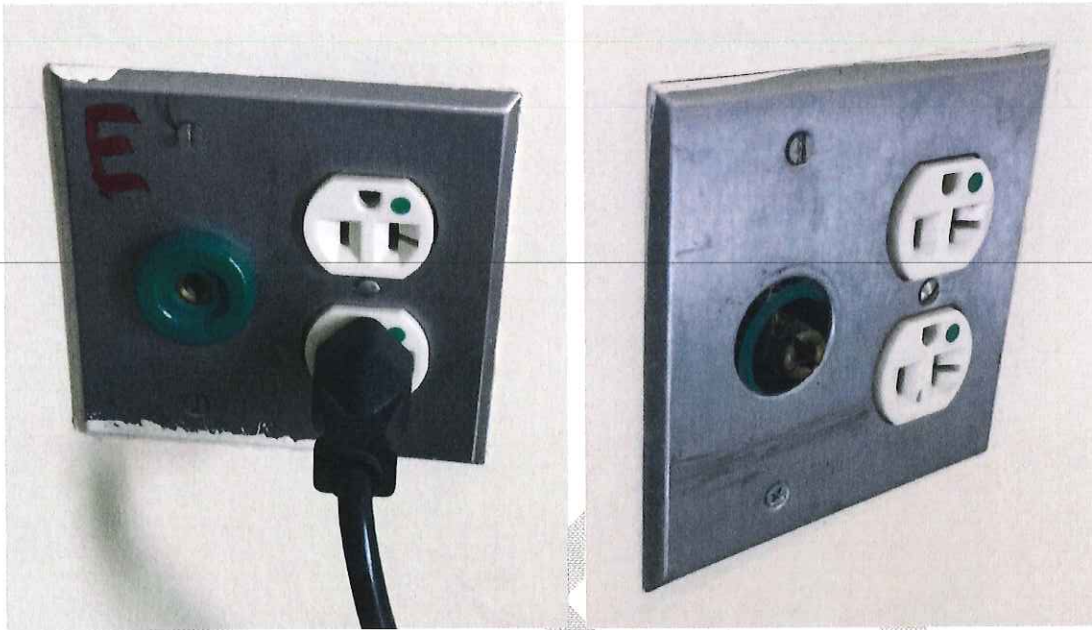
Photo 20 & 21: Resident room receptacles; Red "E" for Emergency, Damaged ground jack.

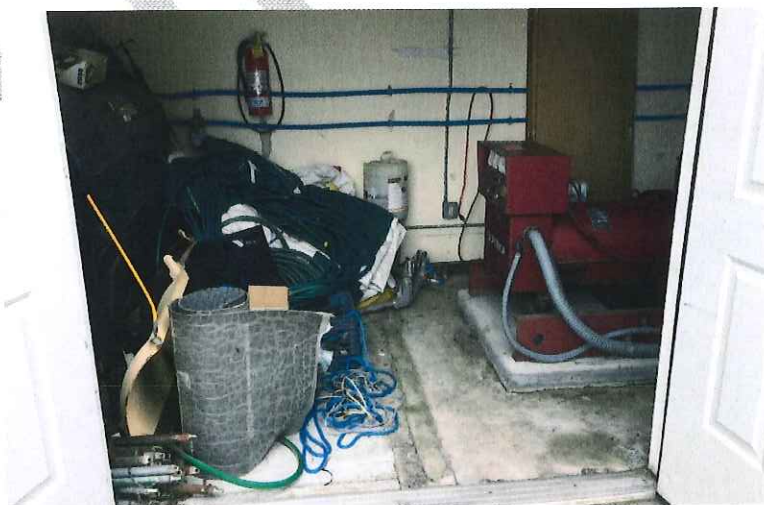
The emergency system consists of a 45 kW Superior brand diesel generator located in a dedicated room in part of a detached wooded storage shed between the South Wing and the dining room. The generator has a 175 amp main breaker that serves two automatic transfer switches in the facility. The generator has a 330 gallon fuel tank located in the same room with the generator. The separation between the generator room and the adjacent storage space did not appear to be 2 hour fire rated. The generator room is being used for storage. The stored items should be moved out of the generator room as they prevented quick and ready access to the generator equipment.

Photo 22: 45kW Superior generator, 330 gallon diesel tank, stored items preventing access.

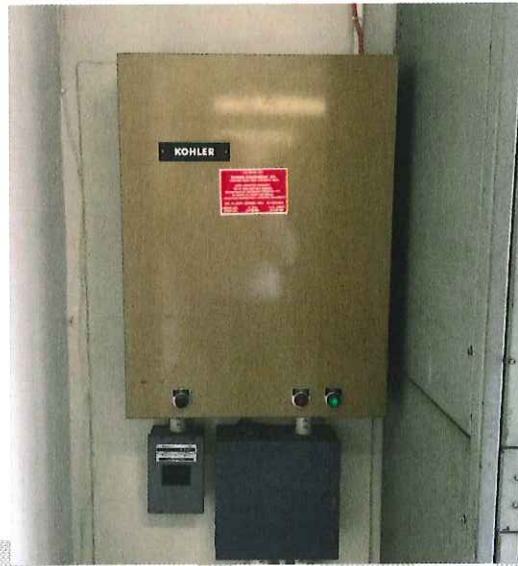
The two automatic transfer switches in the facility include one 30 amp switch and one 104 amp switch. Both switches were manufactured by Kohler. The 30 amp automatic transfer switch is located in the corridor next to the service entrance switchboard at the South Wing exit door. This automatic transfer switch serves panel EPW in the staff core area which appears to be dedicated to Life Safety loads as defined by the Massachusetts Electrical Code. Neither the transfer switch nor panel EPW are in dedicated 2 hour spaces as required by code.

Photo 23: 30 Amp Automatic Transfer Switch adjacent Service Entrance Switchboard.

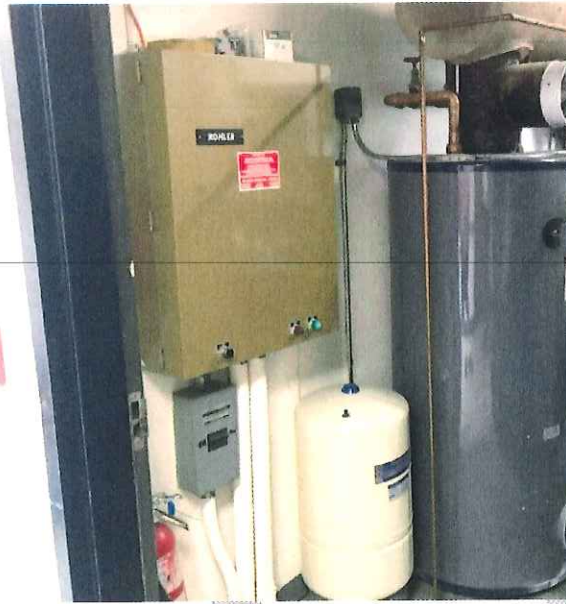
The 104 amp automatic transfer switch is located in the boiler room. This automatic transfer switch serves panel CPS which sub-feeds panels CPW, CPE, IPS and Laundry. All these panels appear to be dedicated to Critical and optional stand-by loads. Serving these two types of loads from the same panelboard is not allowed per the Massachusetts Electrical Code. Neither the transfer switch nor the load panels are located in dedicated 2 hour spaces as required by code.

Photo 24: 104 Amp Automatic Transfer Switch in Boiler Room.

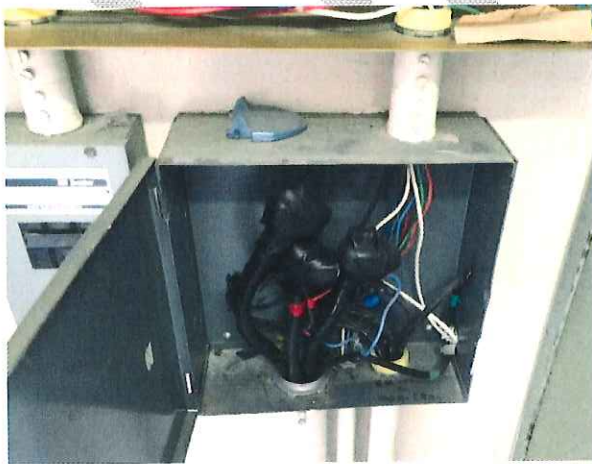
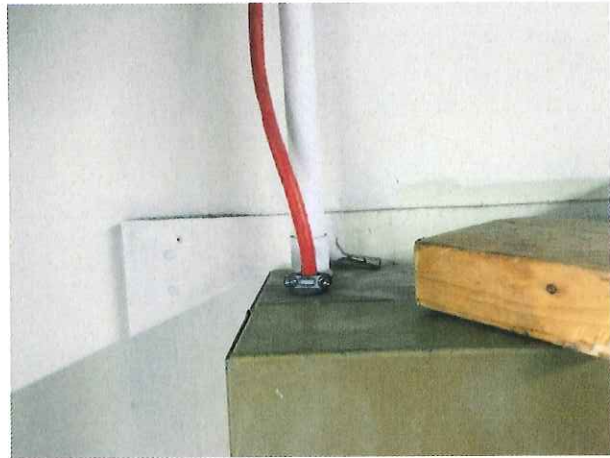
Beneath the 30 amp automatic transfer switch is a junction box which contains the 175 amp feeder from the generator. The feeder is tapped in this junction box to serve the two transfer switches. The tap conductor sizes and lengths do not appear to comply with code requirements for these types of tap connections. In addition, these feeders from the generator and the feeders between the automatic transfer switches to their load panels are not 2 hour rated as required by the Massachusetts Electrical Code.

A control connection was observed between the two transfer switches, comprised of an orange extension cord routed through the ceiling space, with the caps cut off to make connections at the transfer switches' terminal blocks. This installation is not a code recognized wiring method and should be replaced.

Photo 25 & 26: Junction Box with Emergency Feeder Taps; "Extension cord" control wiring.

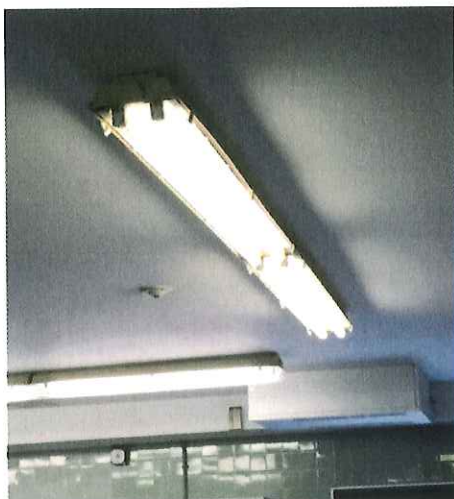
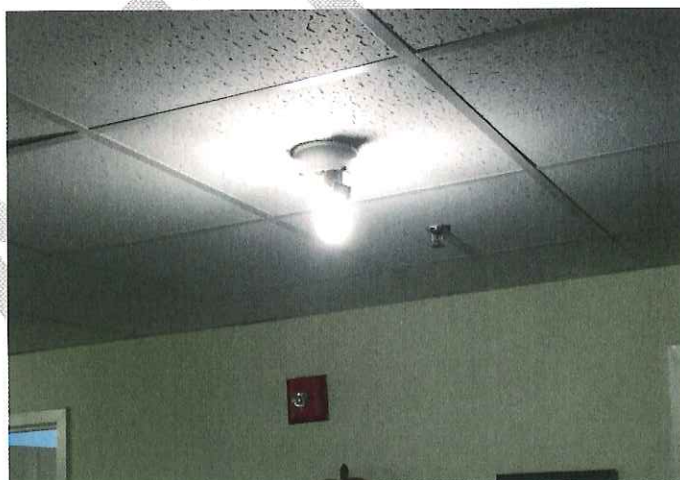
Lighting is a mix of linear fluorescent recessed and surface mounted fixtures, as well as recessed down lights, wall mounted fixtures, chandeliers, and other fixtures. Most fixtures appear to be from the original 1980 construction. It was reported that a comprehensive lighting retrofit was completed on all the fixtures approximately 10 year earlier. The fluorescent lamps that could be observed were T8. Many of the down lights had incandescent lamps. Many fixtures were missing lenses or otherwise damaged. Manual switches are used throughout.

Photo 27 & 28: Surface mounted fixtures with missing lens in Kitchen and Corridor.

It is recommended that occupancy/vacancy sensing switches be installed in offices, staff toilets and other non-patient care related spaces for energy savings. It is recommended that a comprehensive lighting audit be completed to recommend upgrades to replace failed or failing fixtures, improve energy efficiency and to take advantage of any utility rebate or incentive programs available.

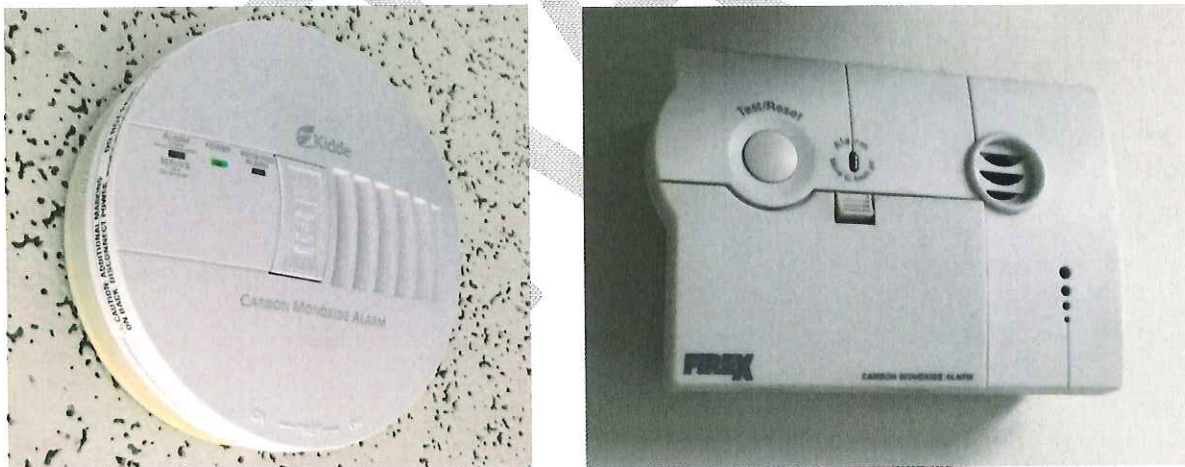
Carbon Monoxide detectors were observed in corridors, but these are believed to be single station (stand-alone) units with integral alarm horns, not connected to the fire alarm system. The carbon monoxide detectors should be replaced with unit that are connected to and report to the fire alarm system.

Photo 31 & 32: Single Station Carbon Monoxide Detectors.

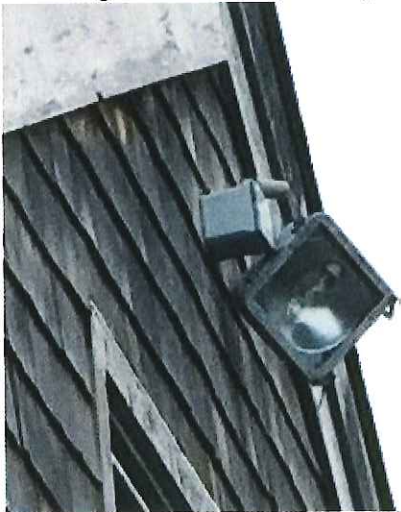
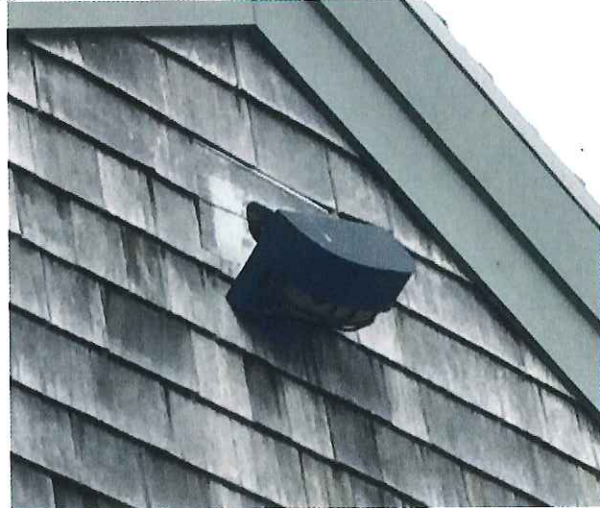
There is a fire alarm master box on the West Wing that is connected to the Nantucket Fire Department. The disconnect switches serving ground mounted condensing unit were rusted on the exterior. Multiple flood lights and other fixtures are mounted on the exterior of the building on all sides. These fixtures are in very poor condition with many in immediate need of replacement. The flag pole has ground mounted lights that were partially covered with dirt and grass.

Photo 35 & 36: Samples of failed exterior light fixtures
