**OUR ISLAND HOME**  
**Existing Building Systems Evaluations**

Our Island Home  
Town of Nantucket  
9 East Creek Road  
Nantucket, MA 02554

SED Associates Corp.  
132 Lincoln Street  
Boston, MA 02111

April 2014

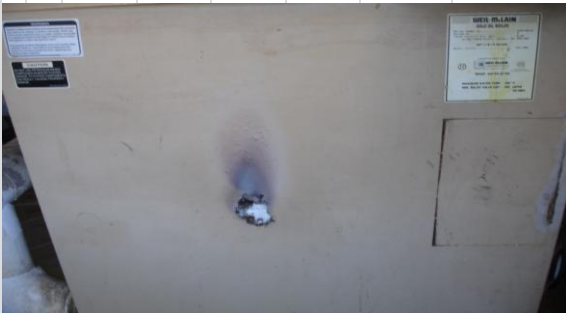
| FACILITY: OUR ISLAND HOME | | | | | | | | | | DATE: JAN 2014 | | | | | | | | | | | | | | | |
|---|---|---|---|--|---|--|--|--|--|---|--|--|---|---|---|---|--|--|--|--|--|--|--|--|--|
| <ol style="list-style-type: none"> <li>Boiler has had section seal failure with burn thru, patched.</li> <li>System controller: Tekmar 254, 4 stages boiler, outside water reset &amp; system start</li> <li>Unit model discontinued by manufacturer, replacement unit not compatible.</li> </ol> | | | | | | | | | | | | | | | | | | | | | | | | | |
| BOILER SIDE PANEL BURN THRU | | | | | | | | | | BURNER | | | | | | | | | | | | | | | |

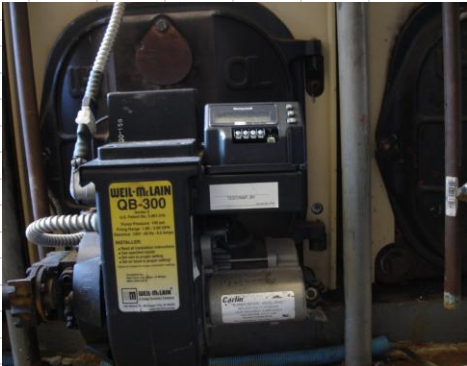
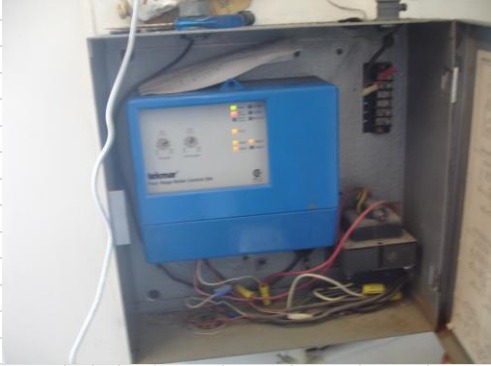
| 1. System controller: Tekmar 254, 4 stages boiler, outside water reset & system start | | | | | | | | | | | | | | | | | | | | | | | | | |
| 2. Unit model discontinued by manufacturer, replacement unit not compatible. | | | | | | | | | | | | | | | | | | | | | | | | | |

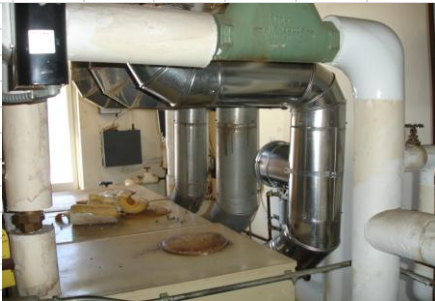
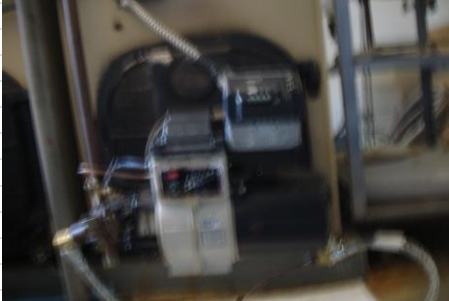
| 1. System controller: Tekmar 254, 4 stages boiler, outside water reset & system start<br>2. Burner refurbished & flue replaced on the unit 01/24/2014<br>3. Unit model discontinued by manufacturer, replacement unit not compatible. | | | | | | | |

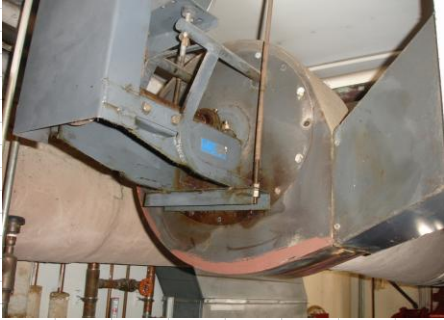
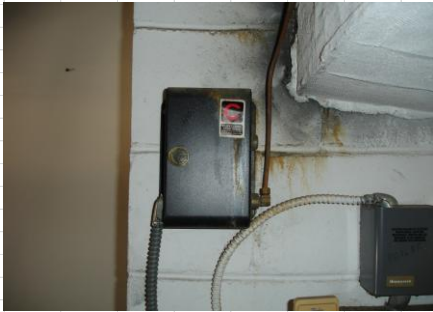
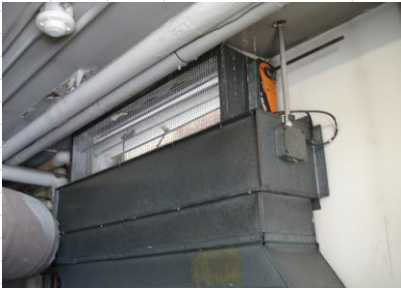
| 1. Manufacture out of bussiness, obsolete.<br>2. Exterior surface corrrison<br>3. Draft fan controller not working, fan runs 24/7. | | | | | | | | | | | |

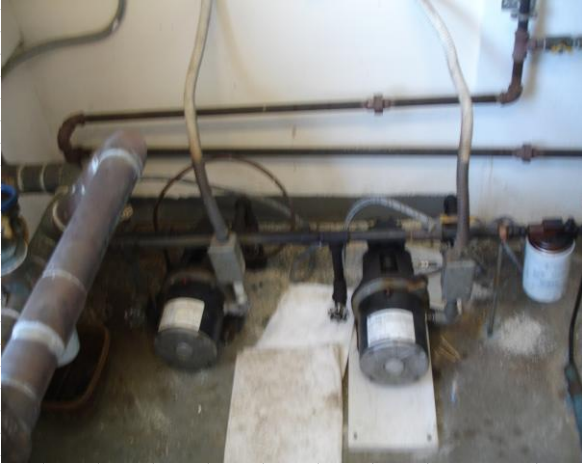
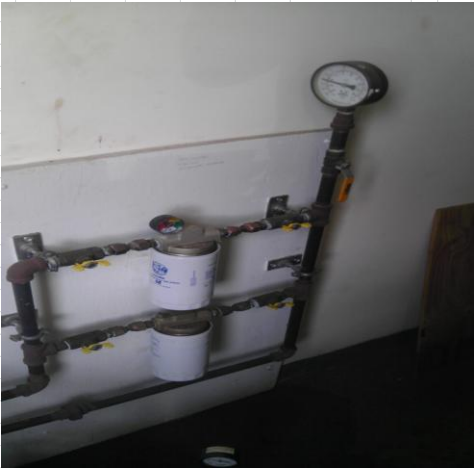
Comment Replacement of OP-1 has exceeded its useful service life and should be replaced.

| <ul style="list-style-type: none"> <li>1. OP-1, original unit.</li> <li>2. OP-2, unit replaced 2014.</li> <li>3. Pumps are manually operated, year round running.</li> </ul> | | | | | | | | | | | | | | | | | | | | | | | | | |

3. Oil Circulation Pumps (OP-1 & 2). Replacement of OP-1

Replacement Cost: 1 pump unit with motor = \$ 750.00 (material)  
piping and accessories = \$ 250.00 (materials)  
1 man x 1 days; 8 hrs. x \$75/hr. = \$ 600.00 (labor)  
\$1,600.00

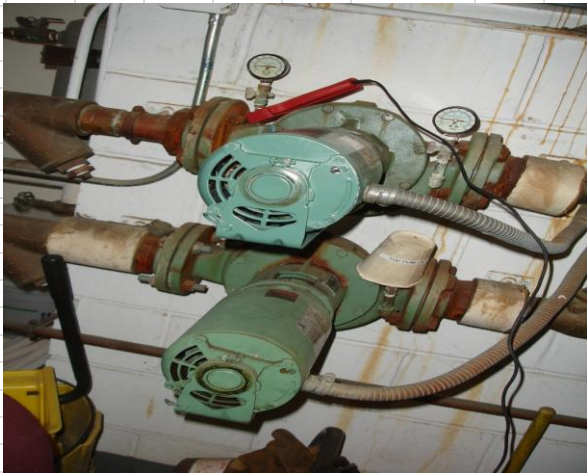
| <ul style="list-style-type: none"> <li>1. Automatic controls part of the boiler system Tekmar controller, start-stop only</li> <li>2. Manual selection of pump sequencing, next up designated by cup.</li> <li>3. Pump P-1(top) motor replaced 2009?</li> <li>4. Pressure gauge missing P-2(bottom)</li> </ul> | | | | | | | | | | | |

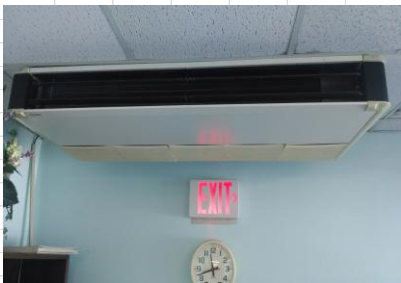
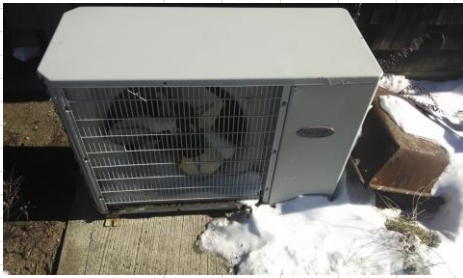
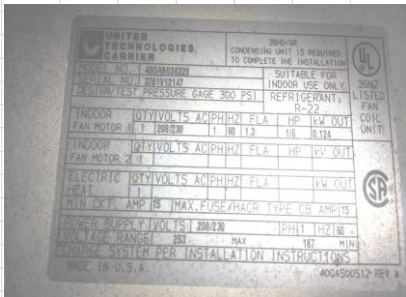
| 1. Refrigeration is R-22 no longer manufactured, replacement refrigerants not compatible.<br>2. Exterior insulation splitting apart. | | | | | | | |

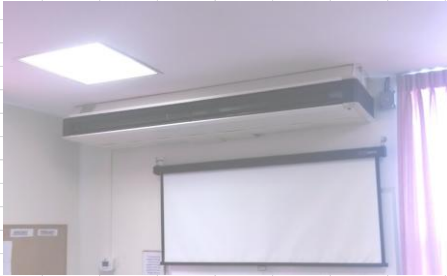
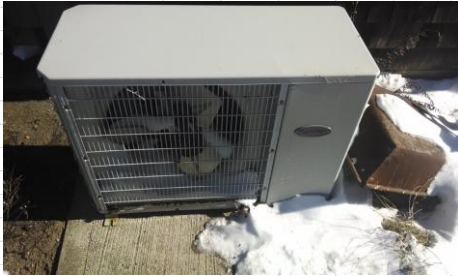
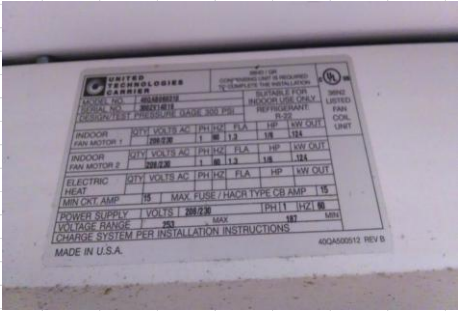
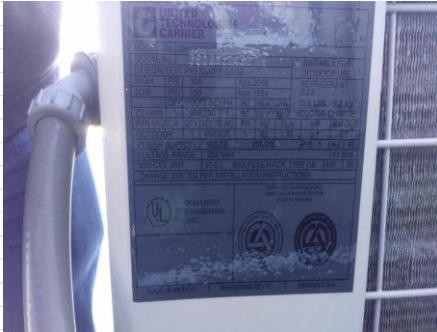
| 1. Refrigeration is R-22 no longer manufactured, replacement refrigerants not compatible.<br>2. Exterior insulation splitting apart. | | | | | | | |

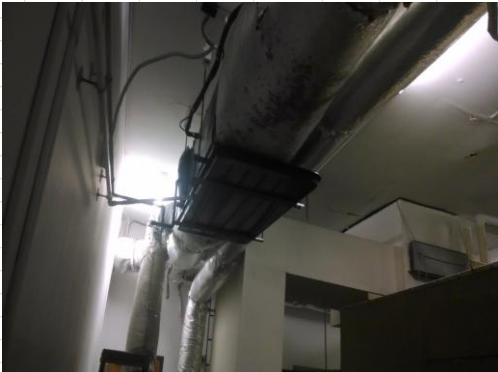
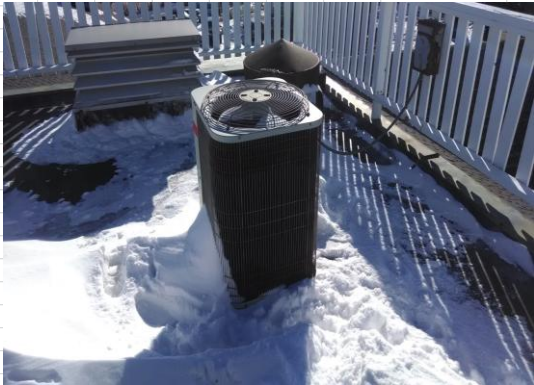
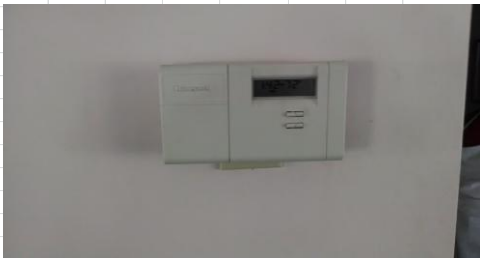
Comment: This unit is the only piece of equipment that supply's fresh and tempered (heated & cooled) air to the central core area that also included the nurse's station. This unit has exceeded its useful service life and should be replaced. Replacement compressors using this refrigerant are being phased out of manufacturing and in the foreseeable future may become unavailable.

| <ol style="list-style-type: none"> <li>Unit model discontinued by manufacturer, replacement unit not compatible.</li> <li>Refrigeration is R-22 no longer manufactured, replacement refrigerants not compatible.</li> </ol> | | | | | | | |

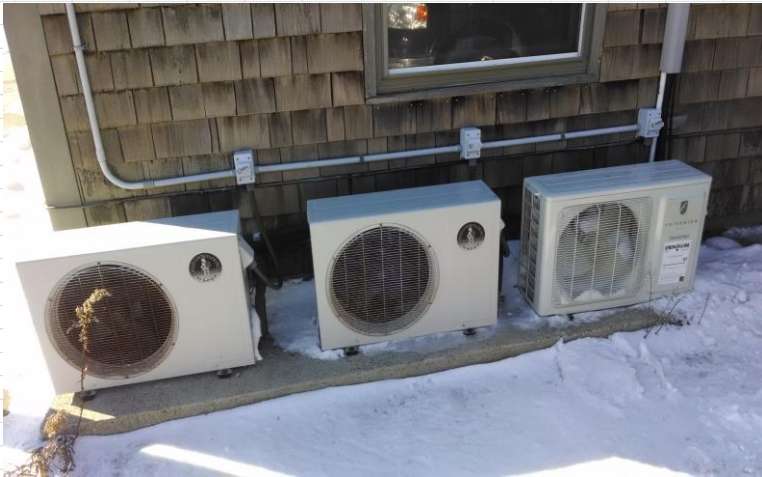
Comment: Two of these units use refrigerant, R-22, that is no longer made and will become harder if not impossible to obtain as a replacement due to any system leakage. Replacement compressors using this refrigerant are being phased out of manufacturing and in the foreseeable future may become unavailable.

| 1. Refrigeration is R-22 no longer manufactured, replacement refrigerants not compatible.<br>2. Exterior insulation splitting apart.<br>3. Medical records unit has exterior corrosion. | | | | | | | | | | | | | | | | | | | |

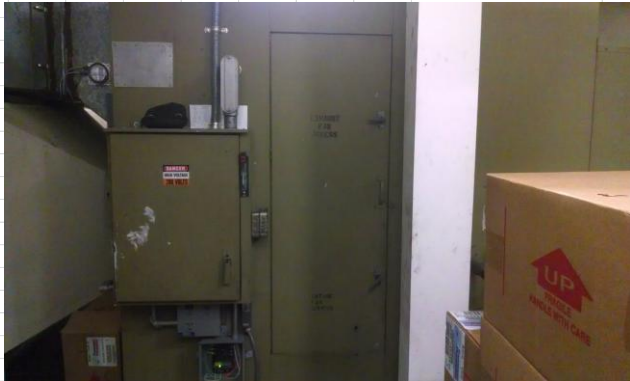
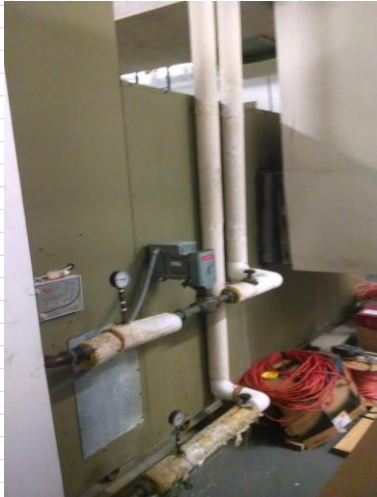
- Dampers, face & by-pass not operational.
- Unit access for normal maintenance is limited that has resulted in limited filter replacement and no cleaning of the heat exchanger core. It was observed that the core has dust/dirt buildup of the surfaces resulting in a loss of the unit efficiency.

Comment: current performance issues includes the lack of heating on colder days, no air condition to dehumidify the summer supply air, service issues and unit being discontinued by the manufacture.

| 1. Unit model discontinued by manufacter, replacemnt unit not compatable. | | | | | | | | | | | | | | | | | | | | | | | |
| 2. Unit controls have been updated, dampers not working, coils and HX dirty, etc, | | | | | | | | | | | | | | | | | | | | | | | |

4. Central energy recovery unit ventilator (HRV) replace in-kind due to its poor performance and current condition. Existing unit, similar capacity without air conditioning, physical size and arrangement.

5. Central energy recovery unit ventilator (DOAS-ERV) replacement, three (3) smaller capacity units dedicated to the three residence wins with heating and air conditioning. Note, air conditioning sized for dehumidification of the outside air not intended to treat the complete occupied space.

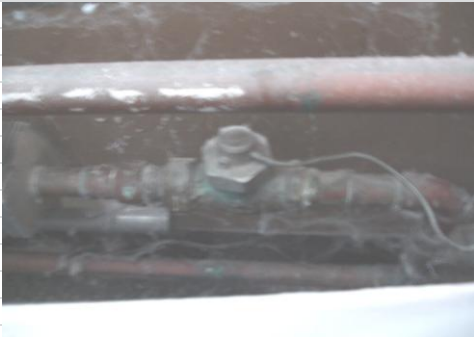
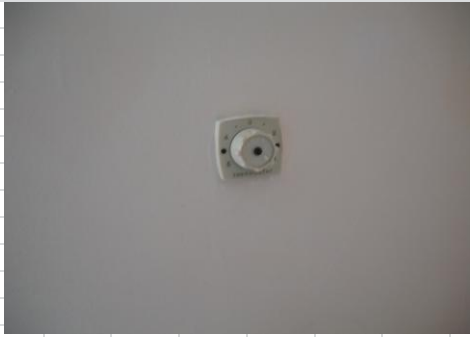
1. Room fin-tube radiators, self-contained thermostats have all exceed their service life and should be replaced. Replacement will provide for improved temperature control and space comfort.

| X | | | End of useful life, replace self-contained thermostatic valves | | | | |

Replacement Cost: 41 units x \$65/unit = \$2,665.00 (material)  
1 man x 3 days; 24 hrs. x \$75/hr. = \$1,800.00 (labor)  
\$4,465.00

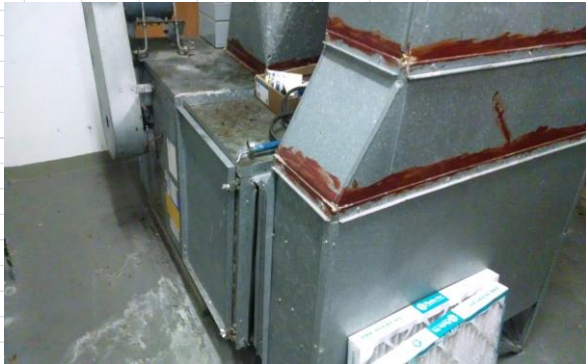
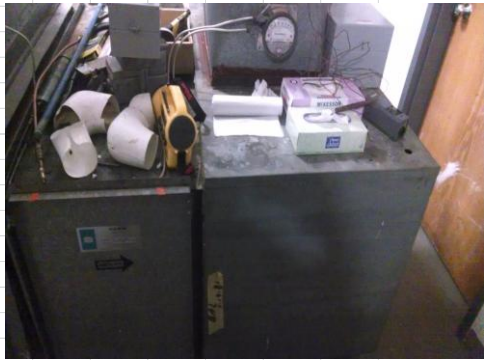
| <ol style="list-style-type: none"> <li>Unit model discontinued by manufactuer, replacemnt unit not compatible.</li> <li>Unit controls have been updated, dampers not working, coils and HX dirty, etc,</li> </ol> | | | | | | | | | | | | | | | | | | | | | | | | | | | | | |

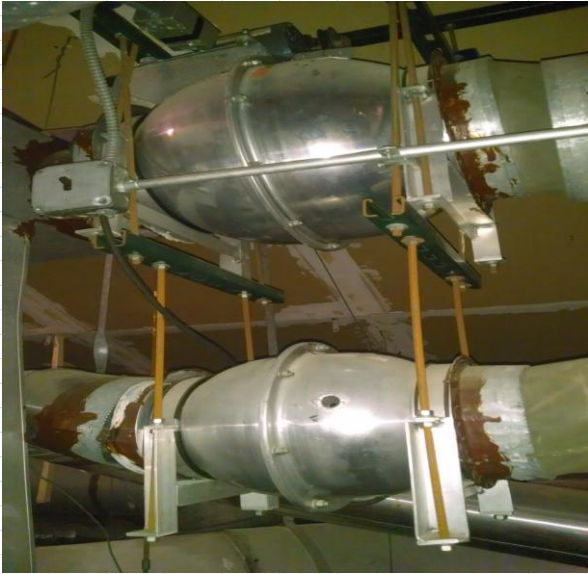
| EF-2 & EF-3 | | | | | | | |

| 1. Unit model discontinued by manufacturer, replacement unit not compatible. | | | | | | | |

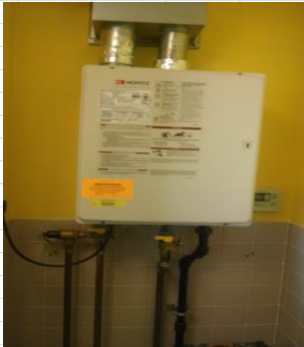
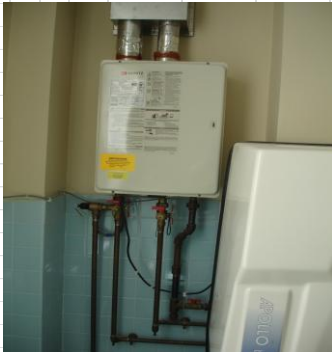
| 1. Unit model discontinued by manufacturer, replacemnt unit not compatable. | | | | | | | |

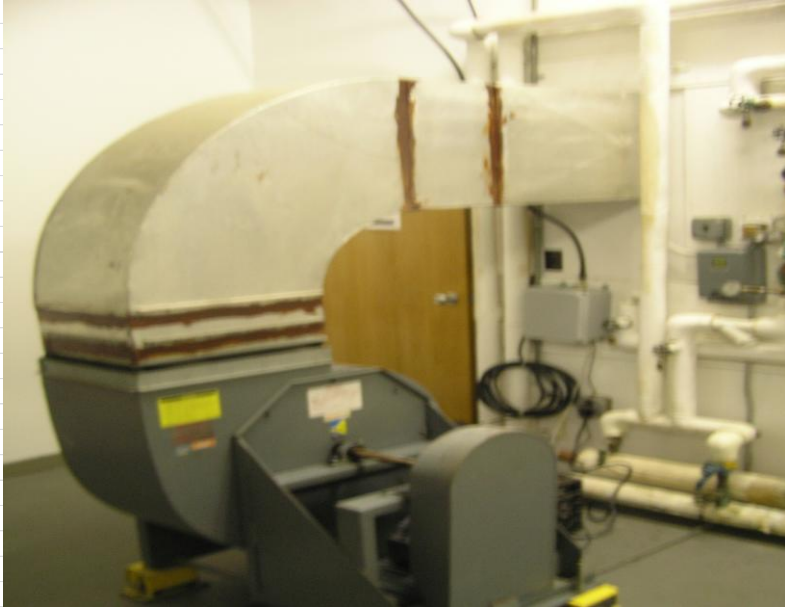
| 1. Unit model discontinued by manufactuer, replacemnt unit not compatable. | | | | | | | |
