4 PLUMBING

5 FIRE PROTECTION

6 ELECTRICAL

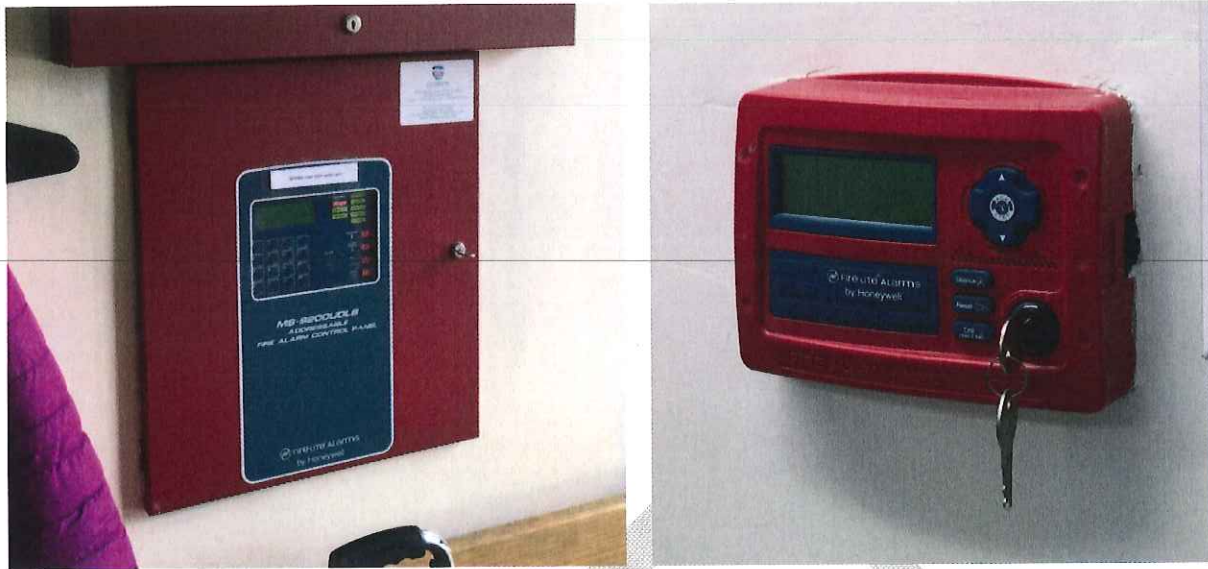
The fire alarm system is a Fire-Lite Alarms system by Honeywell which was installed in 2011. This is an addressable system. There are smoke and heat detectors throughout the building. There are horn/strobes and pull stations at each exit door, and strobes in the public toilet rooms.

Photo 29 & 30: Fire Alarm Control Panel in Entry Vestibule and Annunciator at the Nurse Station.

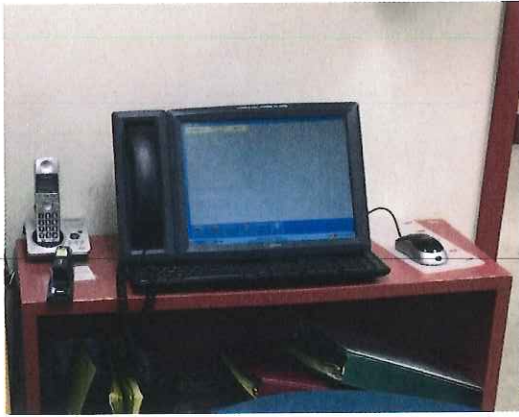
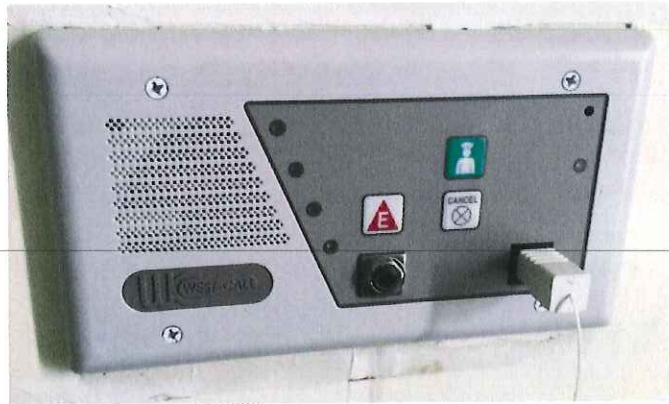
The nurse call system is a tone/voice system, manufactured by West Call and believed to have been installed in 2011 with the fire alarm system. It consists of bed stations, toilet and shower pull stations, corridor dome lights, staff stations, duty stations and a master station at the nurses' desk. The system appeared to be functioning well at the time of the site visit.

Photo 33 & 34: "West Call" nurse call master station and sample bed station.
