**OUR ISLAND HOME**  
**Existing Building Systems Evaluations**

Our Island Home  
Town of Nantucket  
9 East Creek Road  
Nantucket, MA 02554

SED Associates Corp.  
132 Lincoln Street  
Boston, MA 02111

April 2014

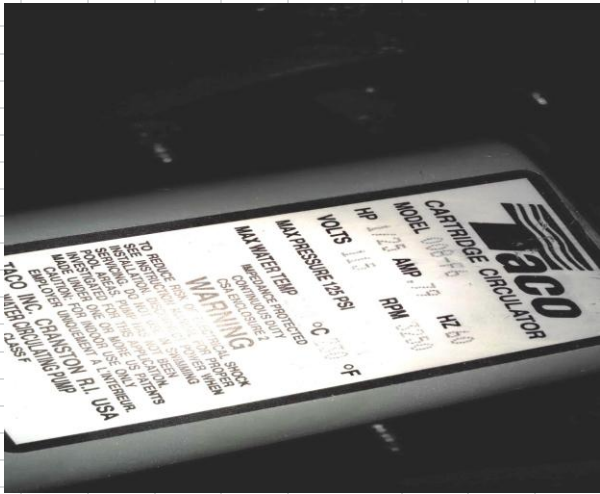
| 1. Located in closet ceiling outside of dining room.<br>2. Manual year round operation, continous. | | | | | | | | | | | |

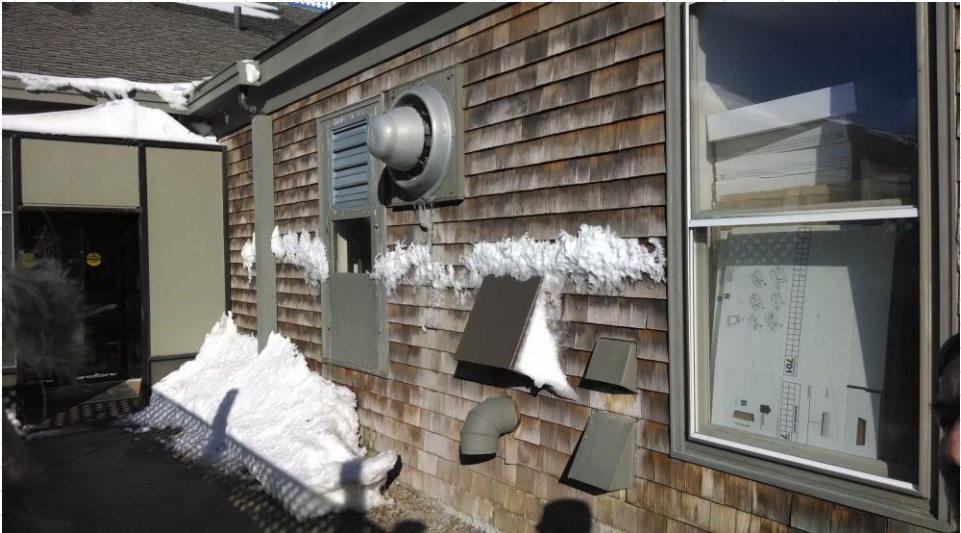
| 1. Intake and exhaust hoods added recently, past year, to comply with DPH requirements. | | | | | | | | | | | | | | | | | | | | | | | | | | | | | |
